**DEPARTMENT OF TRANSPORTATION**

Contract #: 04-0120F4Cty: SF/ALA Rte: 80 PM: 13.2/13.9File #: 99.28**WELDING INSPECTION REPORT****Resident Engineer:**Siegenthaler, Peter**Address:** 333 Burma Road**City:** Oakland, CA 94607**Report No:** WIR-022596**Date Inspected:** 14-Apr-2011**Project Name:** SAS Superstructure**OSM Arrival Time:** 700**Prime Contractor:** American Bridge/Fluor Enterprises, a JV**OSM Departure Time:** 1900**Contractor:** Zhenhua Port Machinery Company, Ltd (ZPMC) Chanxing Island**Location:** Shanghai, China**CWI Name:** Mr. Liu Hua Jie**CWI Present:** Yes No**Inspected CWI report:** Yes No N/A**Rod Oven in Use:** Yes No N/A**Electrode to specification:** Yes No N/A**Weld Procedures Followed:** Yes No N/A**Qualified Welders:** Yes No N/A**Verified Joint Fit-up:** Yes No N/A**Approved Drawings:** Yes No N/A**Approved WPS:** Yes No N/A**Delayed / Cancelled:** Yes No N/A**Bridge No:** 34-0006**Component:** OBG Segment**Summary of Items Observed:**

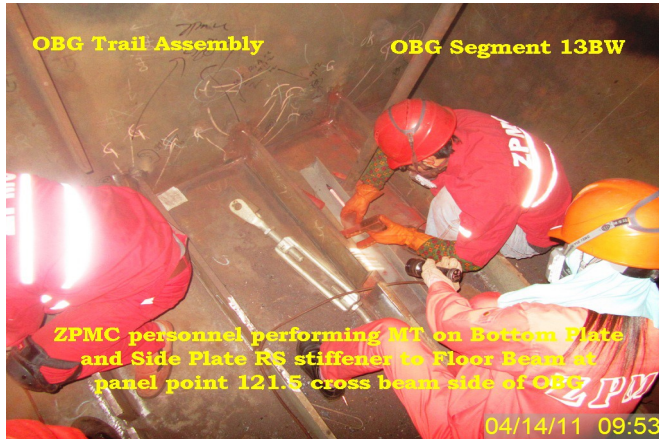
This QA inspector observed ZPMC personnel performed Magnetic particle Testing (MT) on Bottom Plate and Side Plate RS stiffener to Floor Beam at panel point 121.5 cross beam side of OBG Segment 13BW. See the attached picture.
